Limited Visual Dam Safety Inspection Summary Report

HI - 00026

Lalakea Reservoir

May 2006

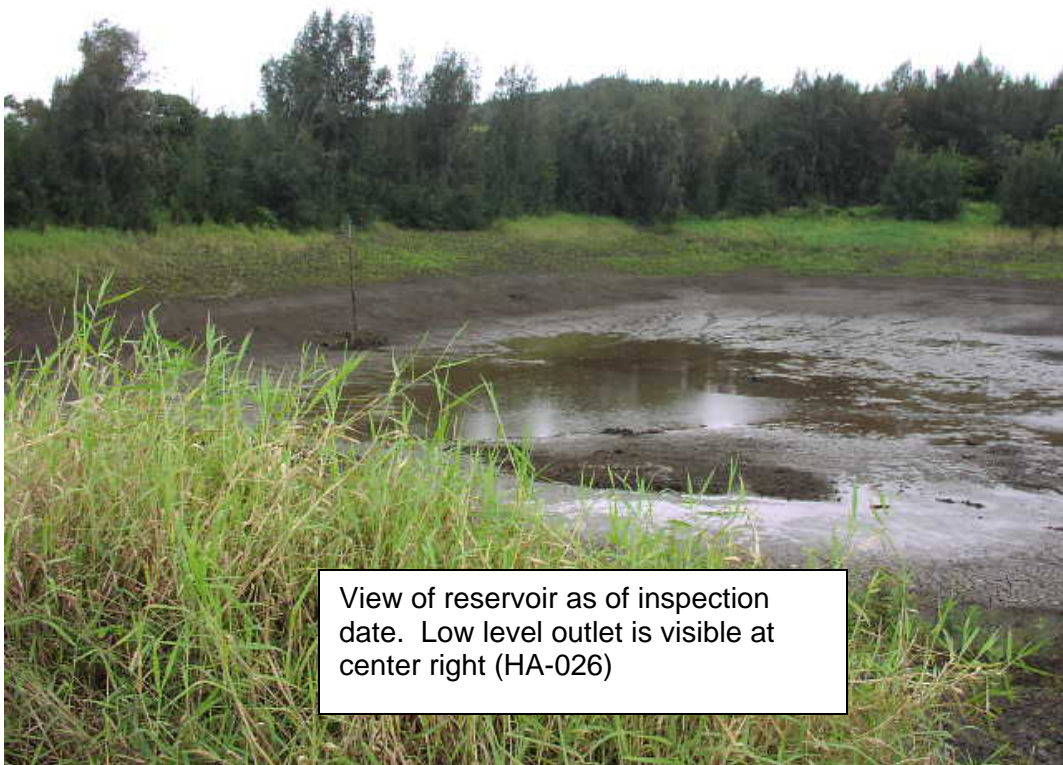
View of reservoir as of inspection date. Low level outlet is visible at center right (HA-026)

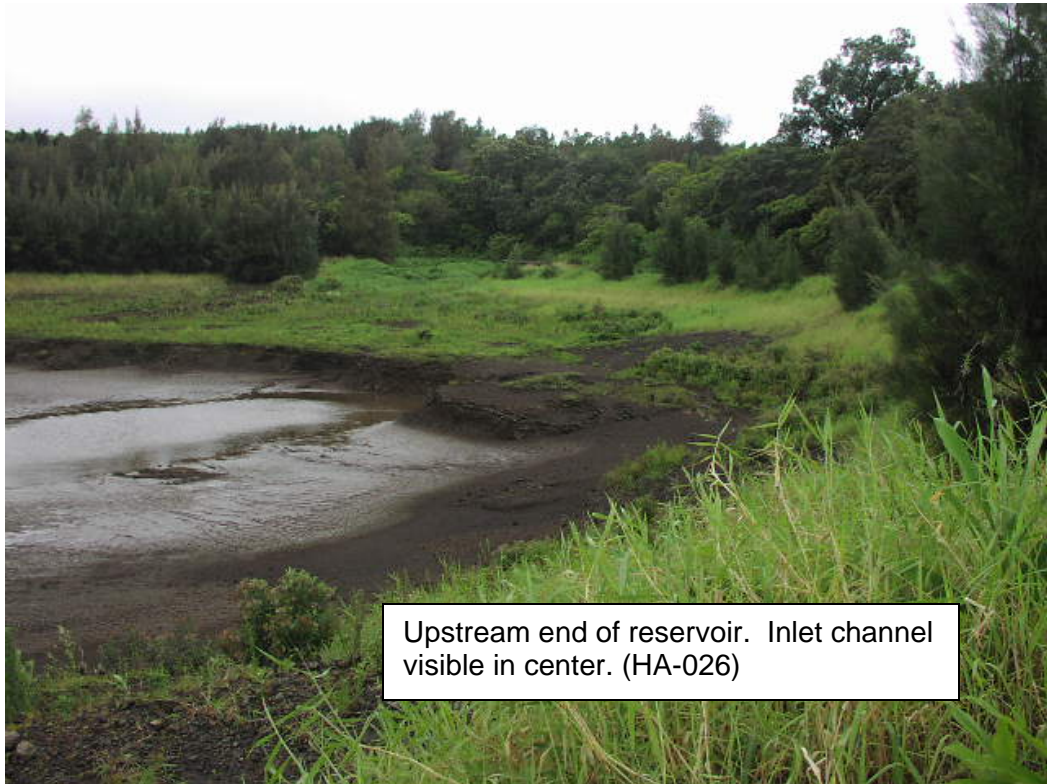
The inflow works were observed but not carefully examined. According to staff personnel, there is one inlet that could feed the reservoir, but it is sealed. This inlet is a 3 ft by 3 ft concrete ditch.

Upstream end of reservoir. Inlet channel visible in center. (HA-026)

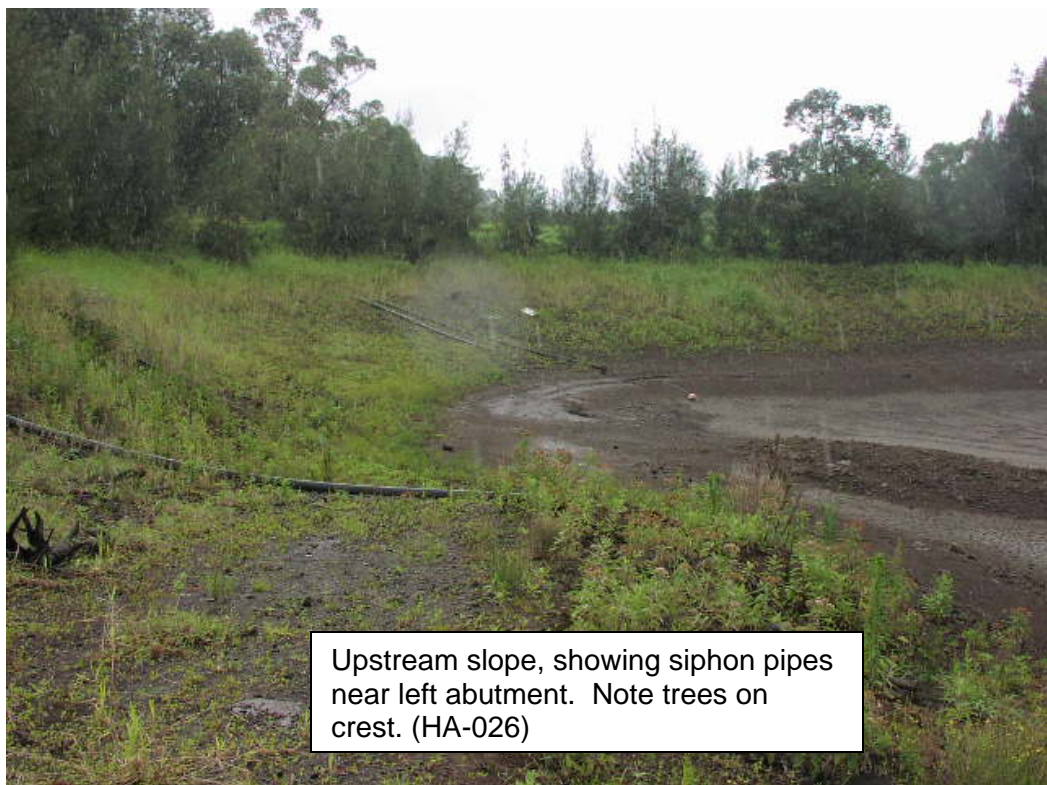
Vegetation observed on the crest ranged from high grass to ginger plants to large trees, principally ironwood.

Upstream slope, showing siphon pipes near left abutment. Note trees on crest. (HA-026)

- d. Tree(s) were observed along the dam crest. Trees have been identified as the probably cause of piping failures, and can possibly cause severe damage to the embankment if they are uprooted during a high winds. Corrective action is required to remove the tree hazards from the dam. Acceptable remedies include removal of the tree and its root structure down to a 2" diameter and reconstructing the damaged embankment section. All repair work shall be accomplished as per the requirements of licensed geotechnical or structural engineer. Routinely monitor the damaged area for signs of settlement and seepage.

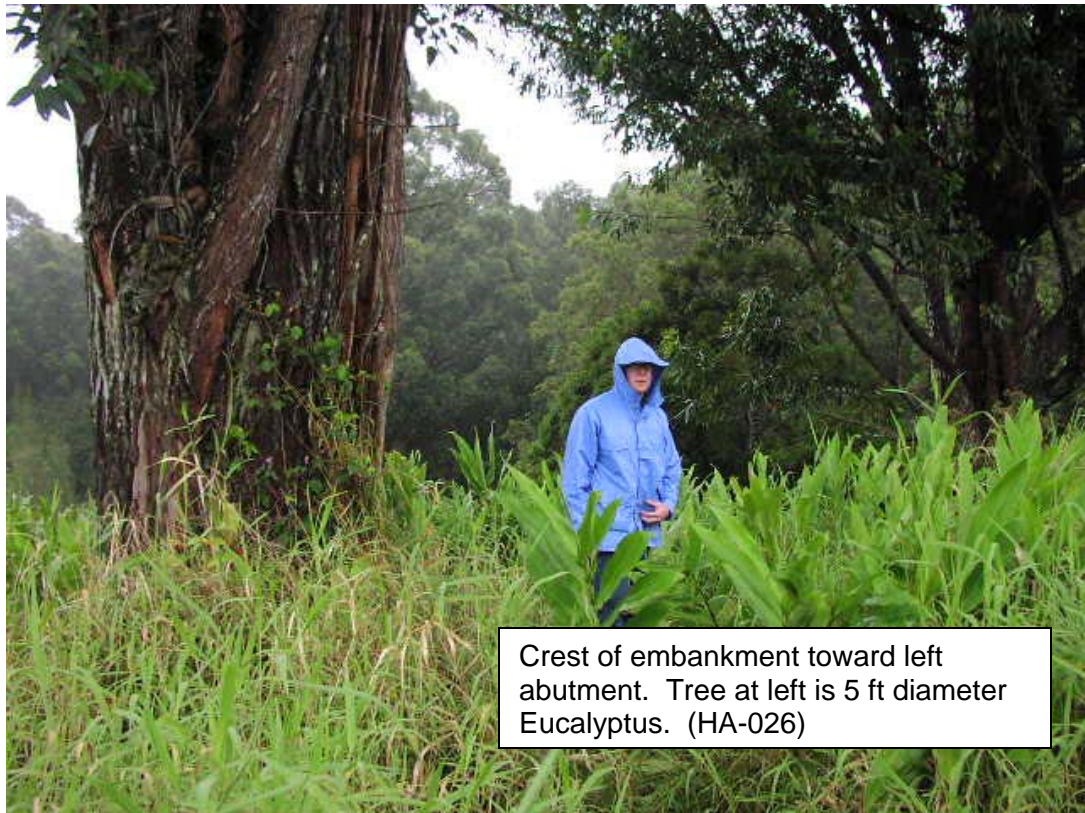
- a. The dam crest appeared to be in poor condition and requires corrective action.
- b. Foot access along one third of the crest was not possible, due to thick vegetation, mostly ginger plants and high grass.

Crest of embankment toward left abutment. Tree at left is 5 ft diameter Eucalyptus. (HA-026)

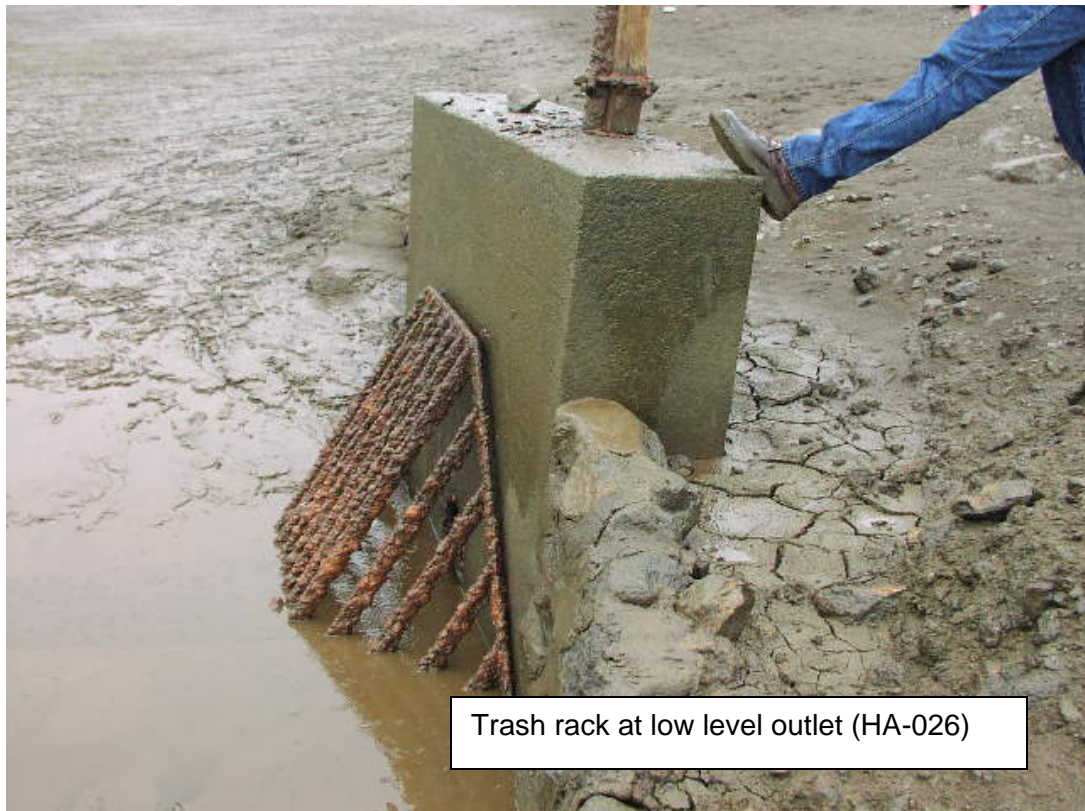
Trash rack at low level outlet (HA-026)

- a. The outlet works were not tested.
- b. The outlet works appeared to be in satisfactory condition, no corrective actions are required at this time.
- c. The terminus of the outlet was not visible due to high grass and bush vegetation. Clear high vegetation and maintain low to enable easy visual inspection.
